INSPECTOR GENERAL

SEPTEMBER 24, 2015

Continental United States Military Housing Inspections – Southeast

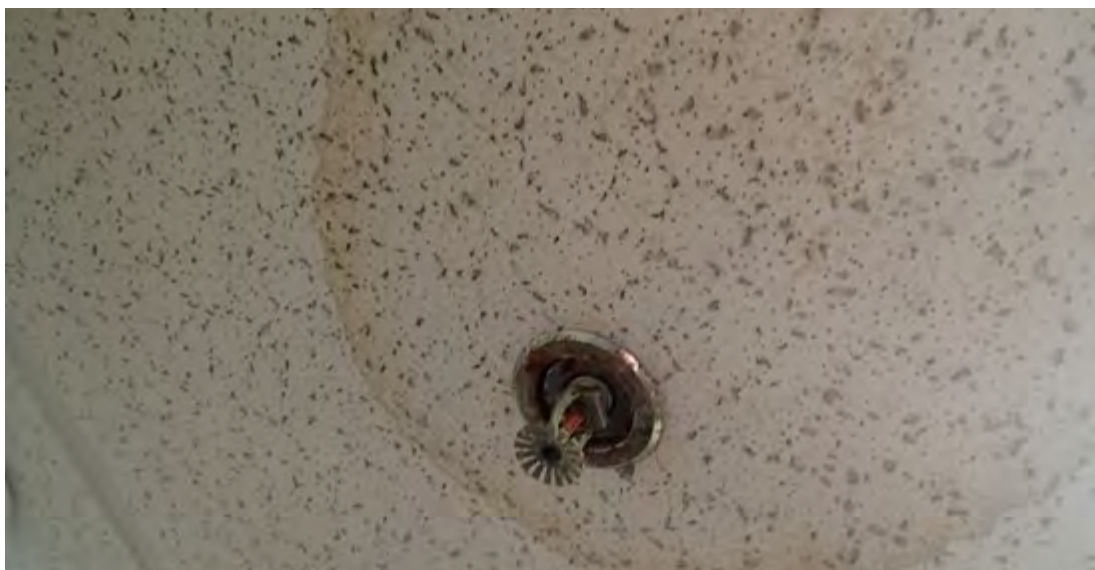
In the unaccompanied housing building, the majority of deficiencies found were related to fire suppression systems and fire/smoke detection, alarm, and mass notification systems. We found various problems with fire suppression sprinklers, damaged and missing riser⁷ components, and a corroded fire department connection.⁸ See Figure 3. Sprinklers were missing components, had corrosion, and had altered surrounding structures, diminishing sprinkler effectivity. Also, none of the common areas of the dormitory building had the required fire alarm notification strobe lights, smoke alarms in each room were improperly configured to activate the entire building alarm, and a mechanical room containing fuel-fired equipment was missing carbon monoxide detection devices. These issues impair the occupants' ability to be made aware of an emergency and safely exit the building in the event of an emergency. Additionally, fire alarm system circuit breakers were not protected with the required locking devices, which could allow the system to be deliberately or mistakenly disabled by unauthorized personnel.

Figure 3. Severely corroded fire suppression sprinkler heads in Patrick AFB's unaccompanied housing building 505. (Deficiency No. PAT-FP-150223-02)
Source: DoD OIG

- 1. Conduct an effective root cause analysis and perform corrective actions for all fire protection deficiencies identified.**
- 2. Verify or create a plan for the performance of ongoing inspection and maintenance of all housing units to applicable fire protection codes and standards.**
- 3. Work with the privatized housing partner to ensure that fire protection inspection and maintenance plans are achieved.**

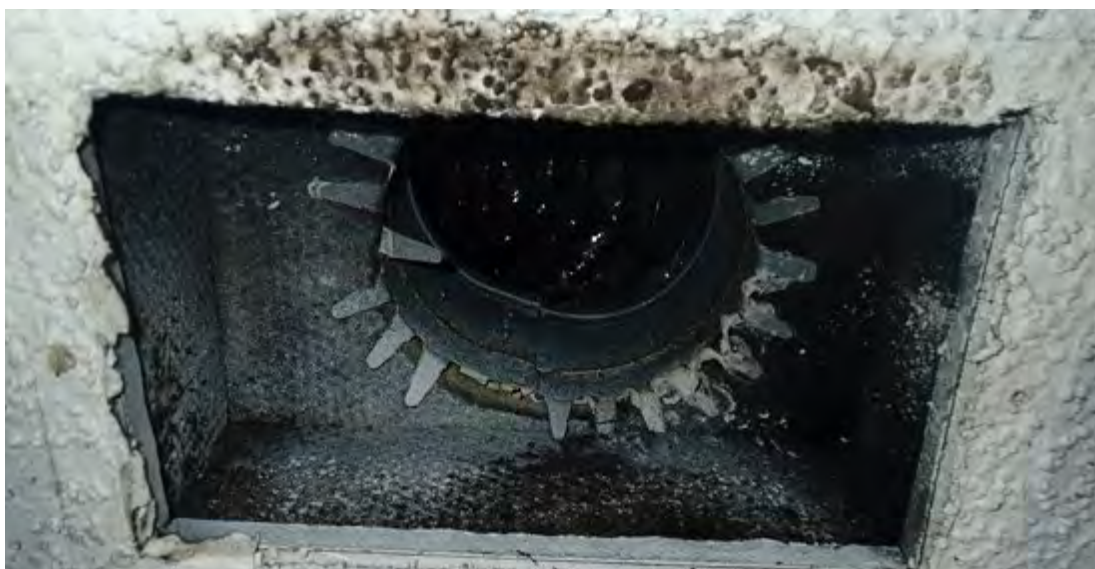
During the inspection of the accompanied housing units, we found instances of mold growth and moisture intrusion inside the laundry room, HVAC ductwork, closet ceilings, and other areas of several units in the older River's Edge and Oceanside neighborhoods.¹¹ See Figure 5. The inspection team collected bulk surface samples of material from the excessively dirty ductwork and sent them for laboratory analysis. The results indicated actively growing mold and/or fungi. In the dormitory building, we also found a few deficiencies related to mold, moisture,

Figure 5. Visible mold and excessively dirty HVAC ductwork in Patrick AFB River's Edge housing unit. (Deficiency No. PAT-EN-150223-015)
Source: DoD OIG

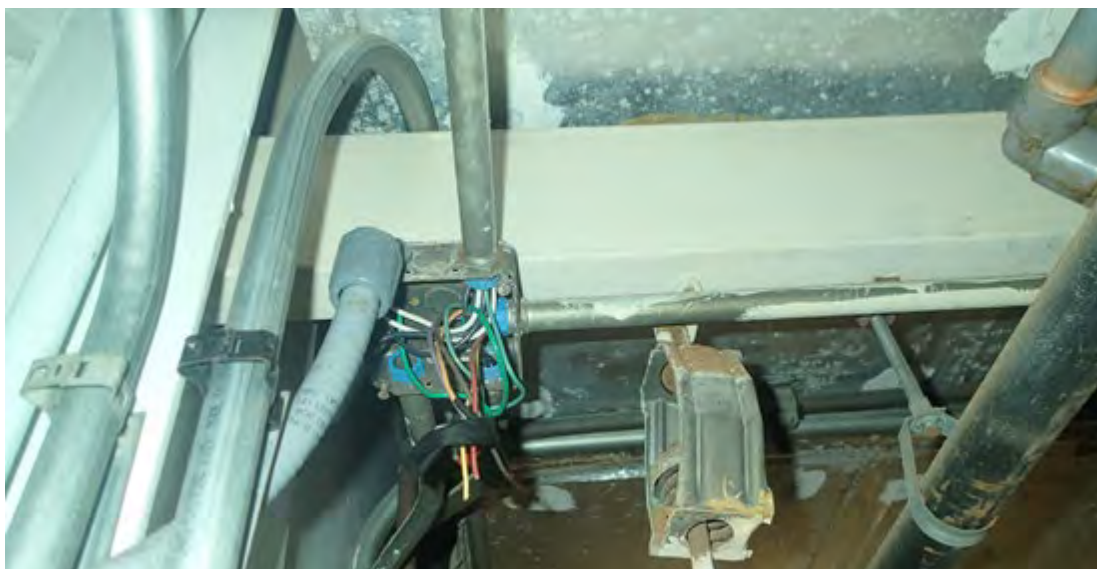
Similarly, in the unaccompanied housing facilities, we found many problems with electrical receptacles, including instances of defective wiring and loose receptacles. We found numerous instances of utility room conduit, electrical panels, and junction boxes that were unsupported, unsecured, improperly terminated, and insufficiently covered (see Figure 8). We also found electrical panels with inadequate access space and improperly labeled circuit breakers. Several other issues we identified throughout the unaccompanied housing buildings included instances of nonfunctional GFCI protection in various locations, including vending machine areas, kitchen areas, and several bathrooms. All of these issues increase the risk of electrical system failure, and ultimately, expose occupants to potential electrocution and fire hazards.

Figure 8. Exposed wiring in a mechanical room of NS Mayport unaccompanied housing building 1587. (Deficiency No. MAY-EL-150302-022)
Source: DoD OIG

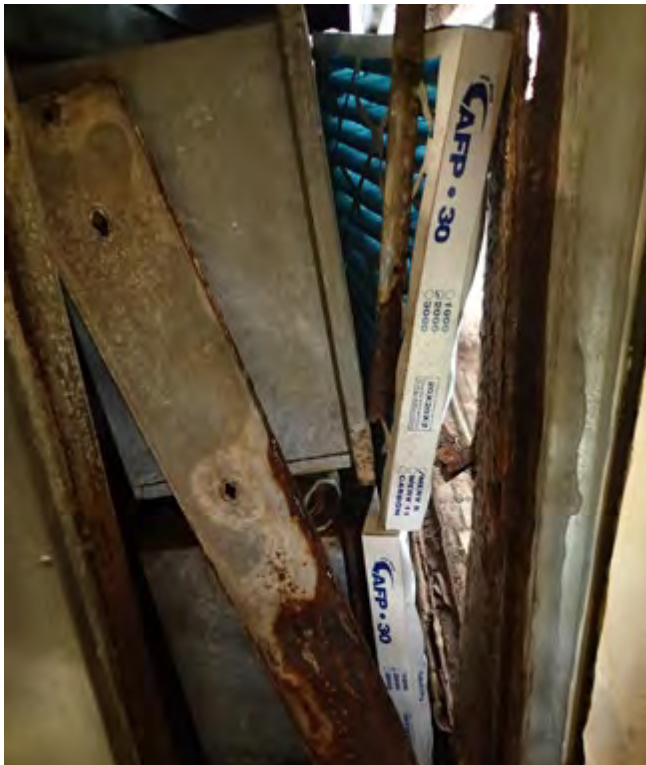
Figure 9. Significantly damaged HVAC filter bank found in NS Mayport unaccompanied housing building 2105. (Deficiency No. MAY-EN-150302-007)
Source: DoD OIG

unfiltered air entering the system through holes and gaps and exposing occupants to potential health hazards. Mold spores may increase respiratory complications among the warfighters and their families.

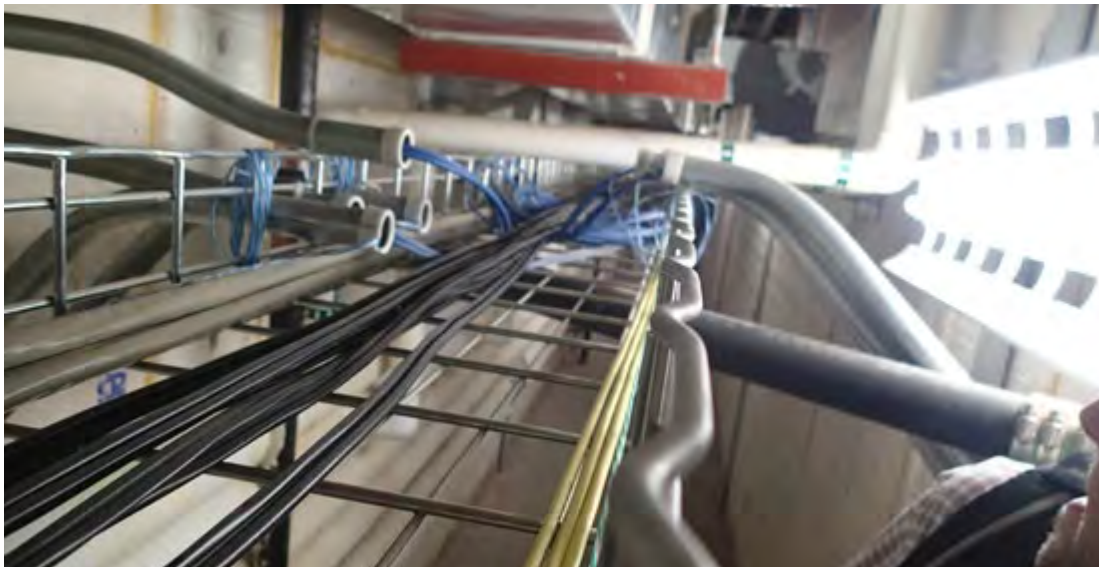
Our inspection team discovered various other structural fire resistance deficiencies, mostly related to the design and construction of the Training Barracks Upgrade Program (TBUP)-renovated buildings. As a result of these renovations, utility room corridors were created that would allow smoke and fire to propagate through the building due to numerous floor and ceiling penetrations. These utility corridors also contained combustible and non-plenum-rated materials. See Figure 11. We found flammable foam insulation not encapsulated throughout various locations in the buildings, which could create toxic smoke in the event of a fire. Additionally, we found protective shipping covers still installed on all smoke detectors inspected in one of the TBUP-renovated buildings (which had been occupied for about a year), rendering the smoke detection system ineffective.

Figure 11. Combustible and non-plenum-rated materials present in Fort Gordon's TBUP-renovated building utility corridors used as airways. (Deficiency No. FGN-FP-150309-053)
Source: DoD OIG

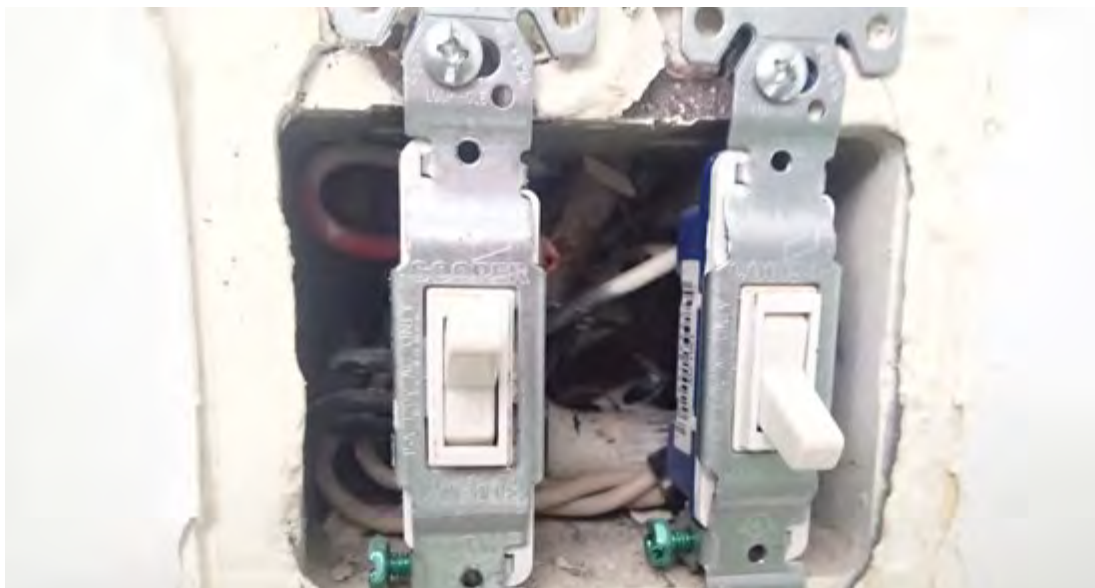
The most significant issue we found was the ground conductors on light switches (see Figure 13) were not connected throughout the homes inspected in the Gordon Terrace, McNair Terrace, and Olive Terrace neighborhoods. In the event of a short circuit to the metallic light switch body, the ground conductor would prevent an individual from being exposed to potentially lethal voltages. We also identified problems with electrical receptacles and wiring as well as the lack of GFCI-protected receptacles in the kitchen areas of a few homes inspected.

Figure 13. An ungrounded light switch in a Fort Gordon family housing unit.
(Deficiency No. FGN-EL-150309-085)
Source: DoD OIG

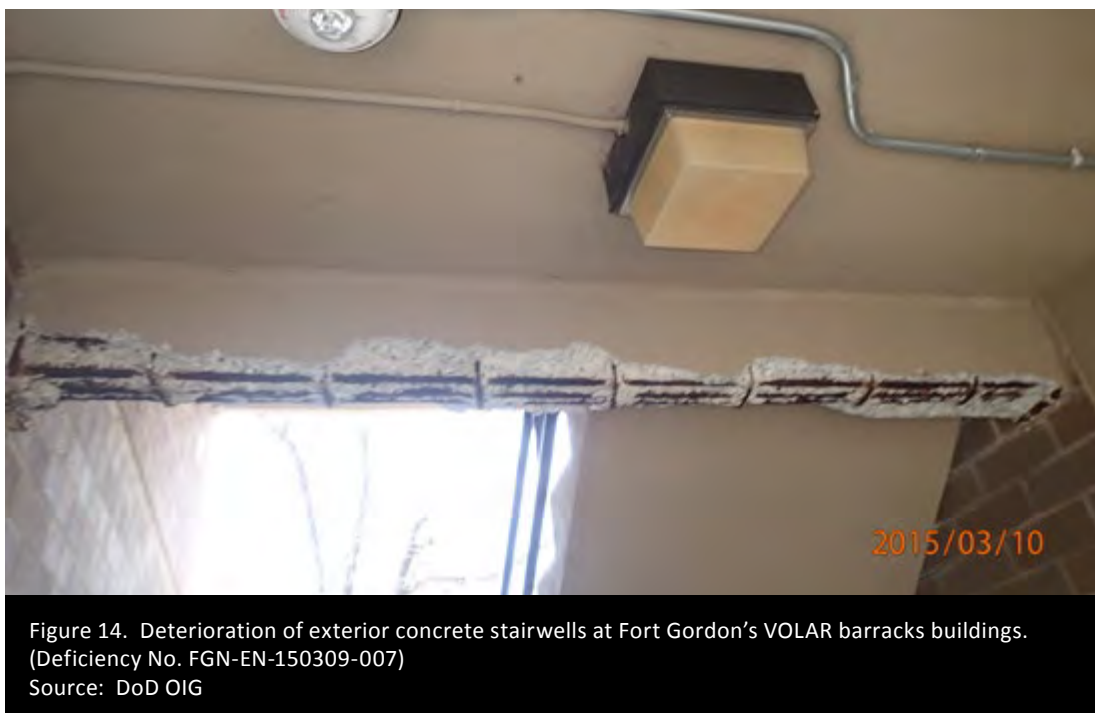
In building 25421 of the volunteer Army (VOLAR) barracks, we also found deteriorating exterior stairwells (see Figure 14). Crumbling concrete and exposed, corroded reinforcing steel bars were observed on the underside of the stairwell. In November 2014, the U.S. Army Corps of Engineers performed a study to determine the extent of the stairwell damage throughout all of the VOLAR barracks buildings. In its January 2015 report, "One-Stop Assessment of Buildings 25000 – 28000 Stairwells; Fort Gordon, Augusta, Georgia," the U.S. Army Corps of Engineers stated that the majority of the VOLAR barracks buildings had at least mild deterioration, and several of the buildings had severe deterioration (including building 25421). The U.S. Army Corps of Engineers (USACE) recommended replacement of the seriously damaged staircases as well as the repair of the other damaged staircases.

Army Installation Management Command provided a point paper dated June 25, 2015, indicating that structural engineering analysis determined imminent failure of the stair system was not probable. As of July 2015, the Army had funded the Savannah District of USACE to develop a request for proposal to replace the stairwells at one of the damaged buildings and estimated that a contract could be awarded by September 2015. An Army official stated that the other buildings requiring similar repair would be addressed in future years. If the structural integrity of building material is not maintained and continued deterioration is allowed to occur, then there is an increased risk of the stairwells and other structures collapsing, potentially resulting in a critical injury.
